UNDERWATER BRIDGE INSPECTION REPORT

STRUCTURE NO. 73533

SAUK RIVER

DISTRICT 3 - STEARNS COUNTY

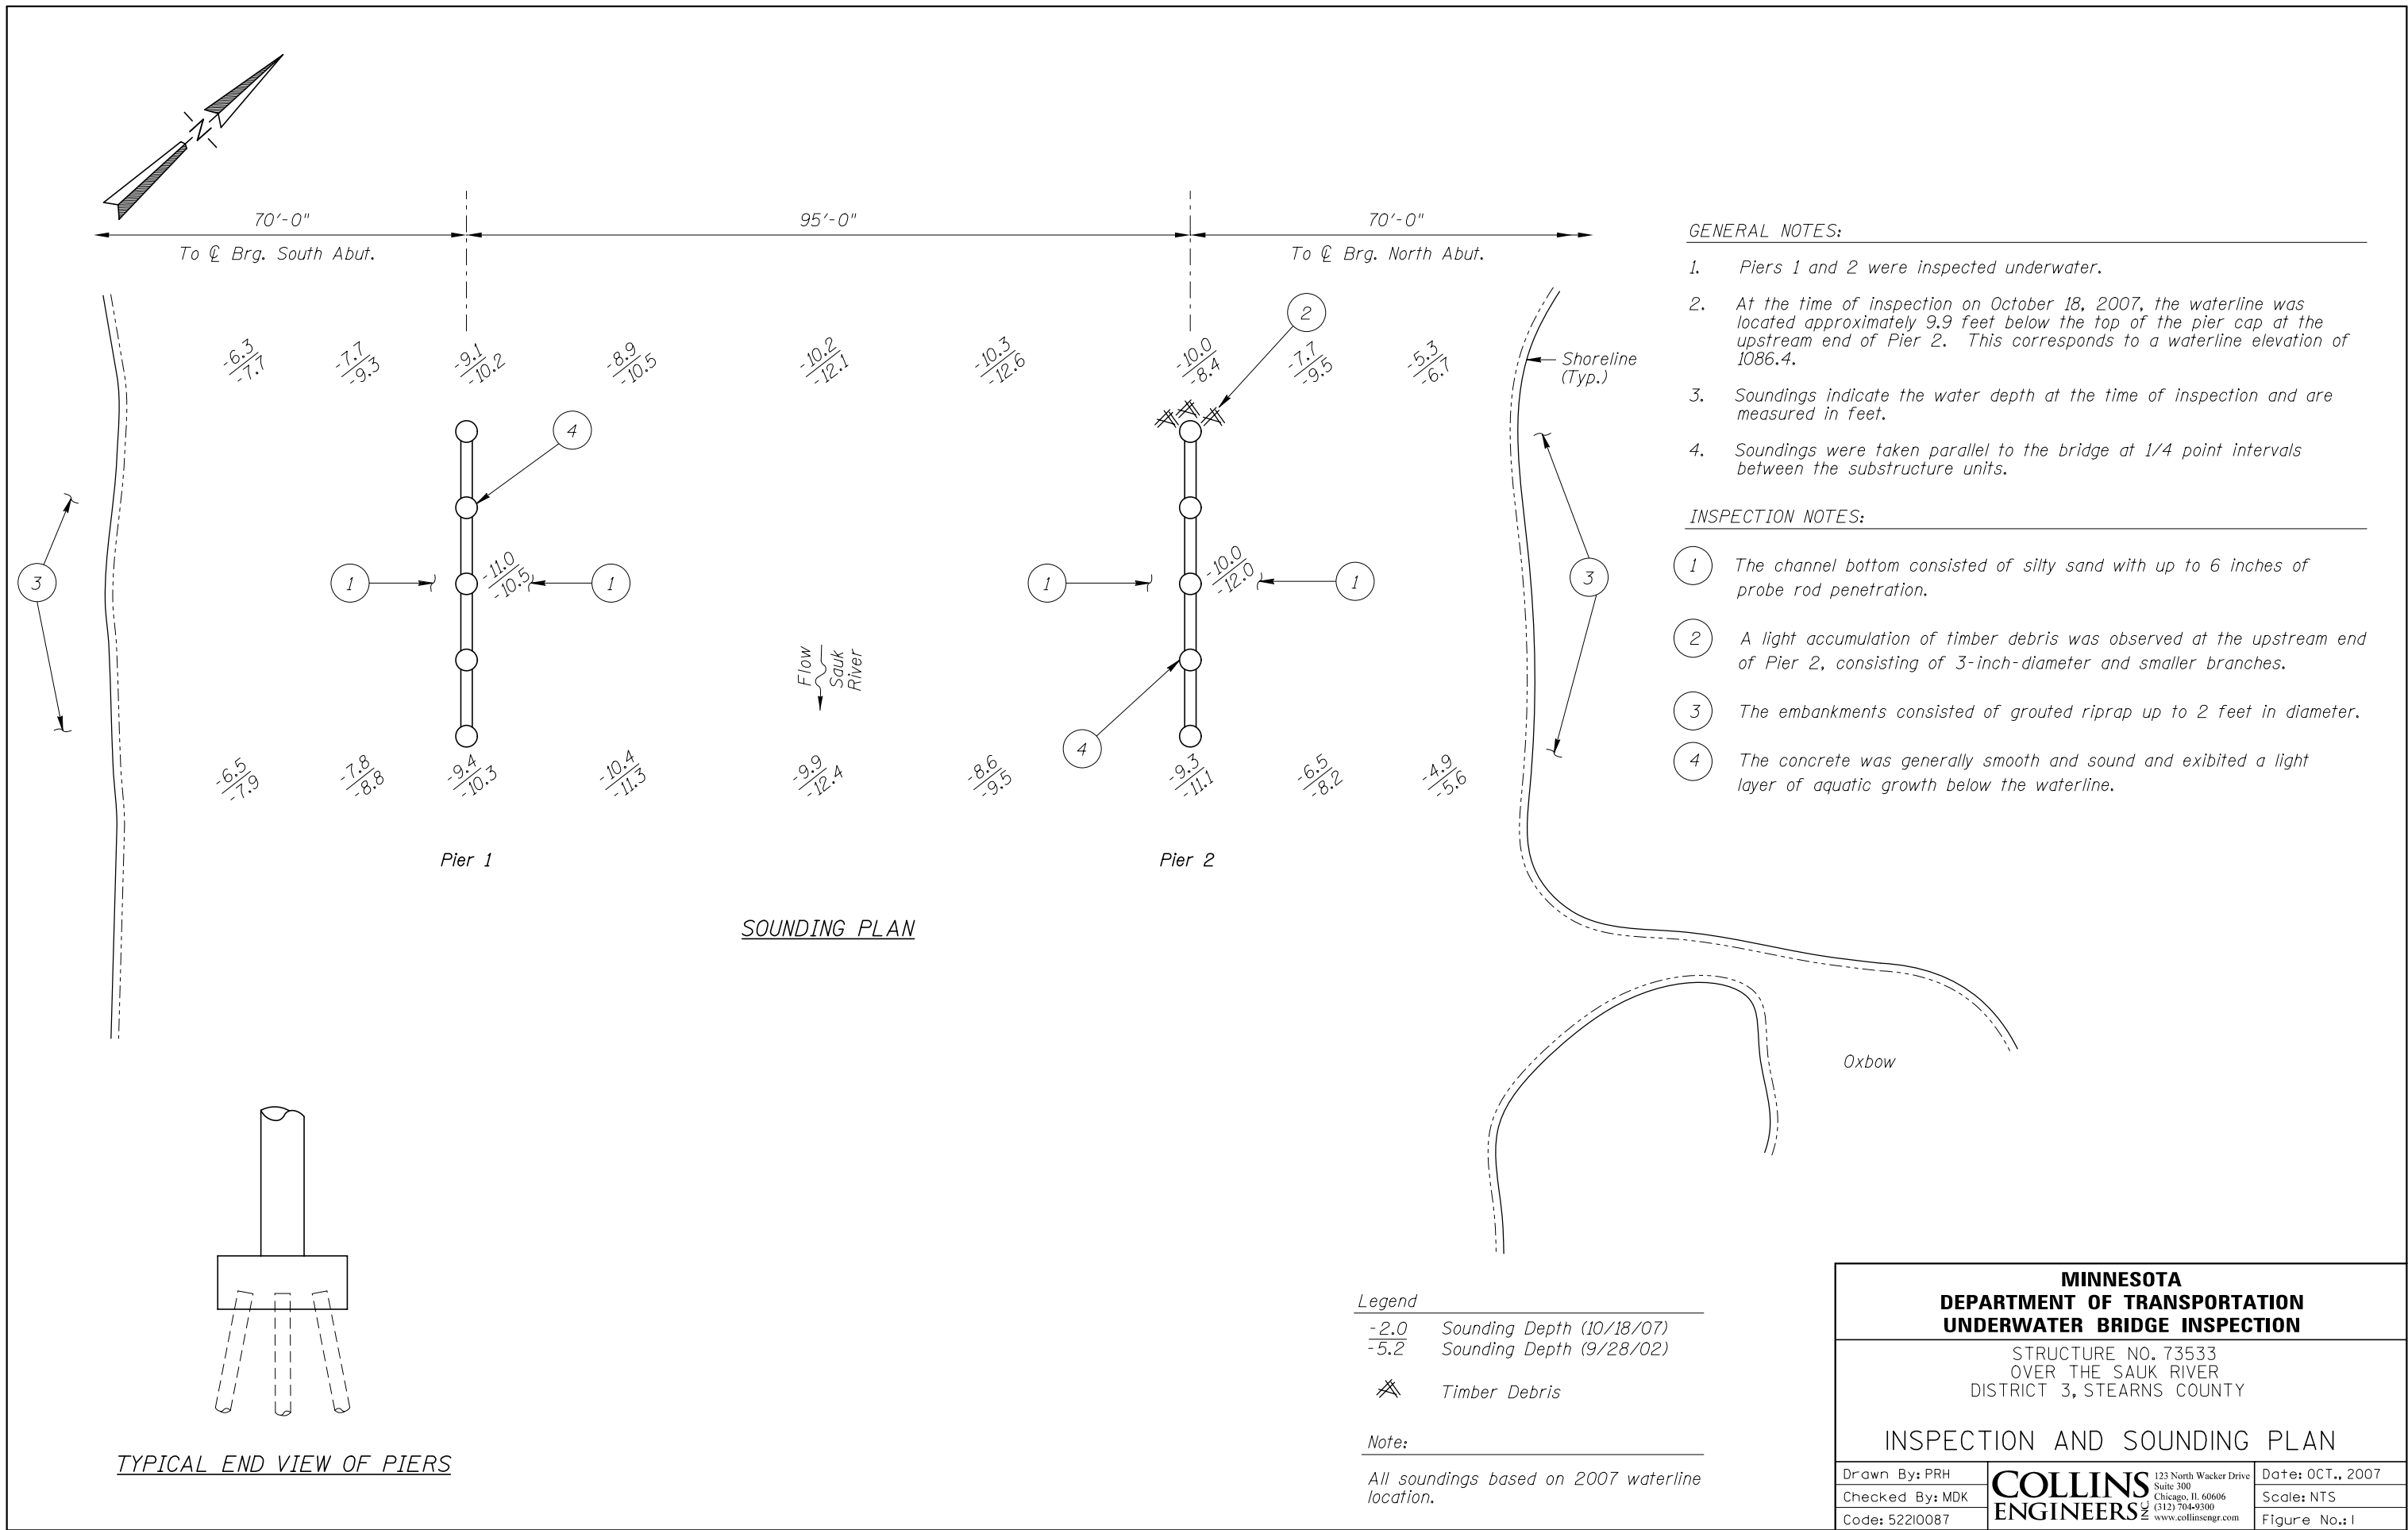
Photograph 2. View of Pier 2, Looking North.

- (A) The concrete of the piers was in good and sound condition with no notable defects.
- (B) A minor accumulation of timber debris consisting of branches 3 inches in diameter and smaller was observed around the upstream nose of Pier 2.

A minor accumulation of branchy timber debris was observed around the upstream nose of
Pier 2. The channel bottom appeared to be in stable condition with no appreciable changes
since the previous inspection.

- (A) Reinspect the submerged substructure units at the normal maximum recommended (NBIS) interval of five (5) years.
